Memorandum

RE: *District 6 Speed Bump Recommendations – The Villages, Florida*
Kimley-Horn Project No: 142202004

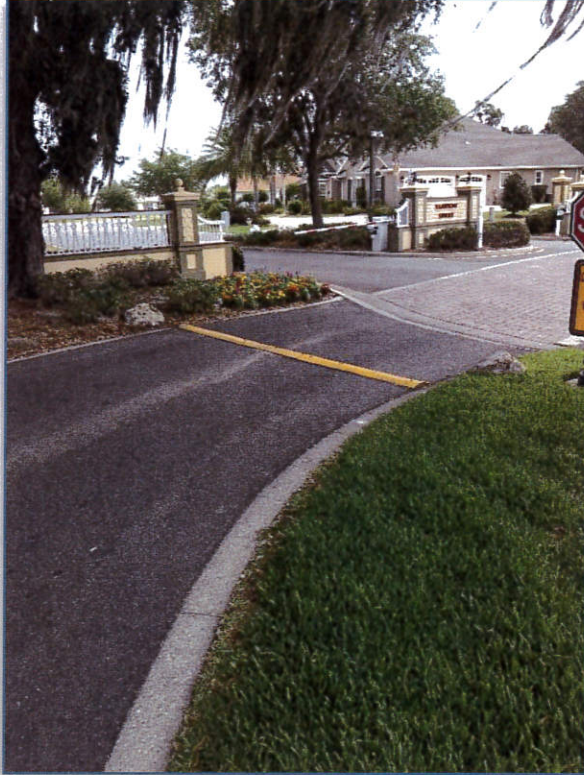
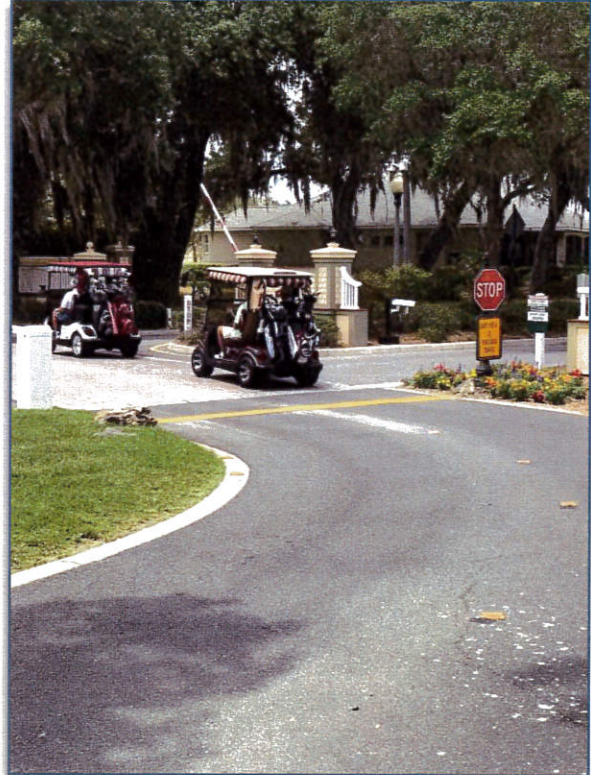
The Village of Bridgeport at Lake Sumter

The multi-use trail at this location has a stop sign on both sides of the crossing at Ternberry Forest Road. An alternate stop sign bollard is located within the median crossing of Ternberry Forest Road. A caution sign stating that "carts yield to vehicular traffic" is mounted below the stop signs. Speed bumps are installed at this location and span the width of the paved multi-use trail from edge to edge, creating potential hazards for bicyclists and pedestrians.

These speed bumps should be removed.

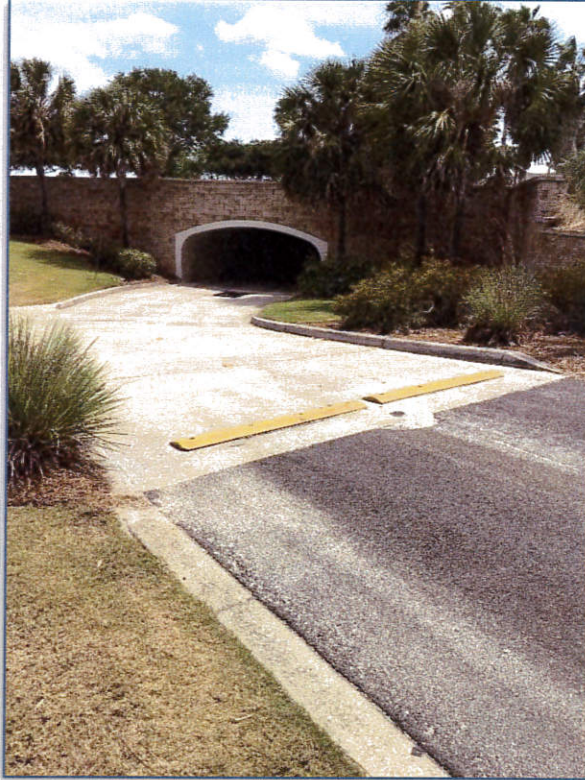
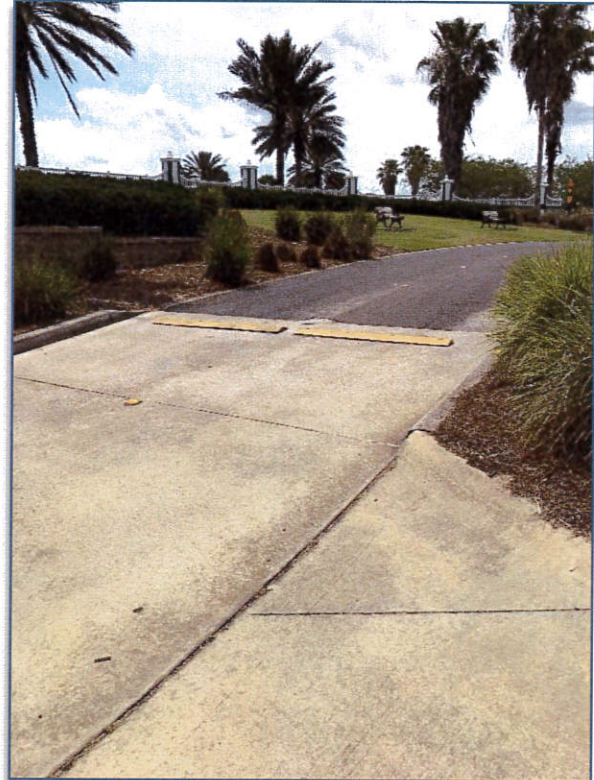
Between Tunnel M7 and Odell Circle

The speed bump along the multi-use path between Tunnel M7 and Odell Circle is located at a free-flow location where golf carts are not required to stop. There are no stop signs, stop bars, or stop bollards within the direct vicinity of the speed bump. Speed bumps at this location span nearly the complete width of the concrete multi-use trail, creating potential hazards for bicyclists and pedestrians.

These speed bumps should be removed.
