**BRIDGEPORT AT LAKE SUMTER RESIDENT  
PRESENTATION TO VCDD5 AND VCDD6  
JUNE 2, 2017**

**A BLS Resident Perspective of Issues at the Entry and Exit  
Gate Area and the Multi Model Path Crossing**

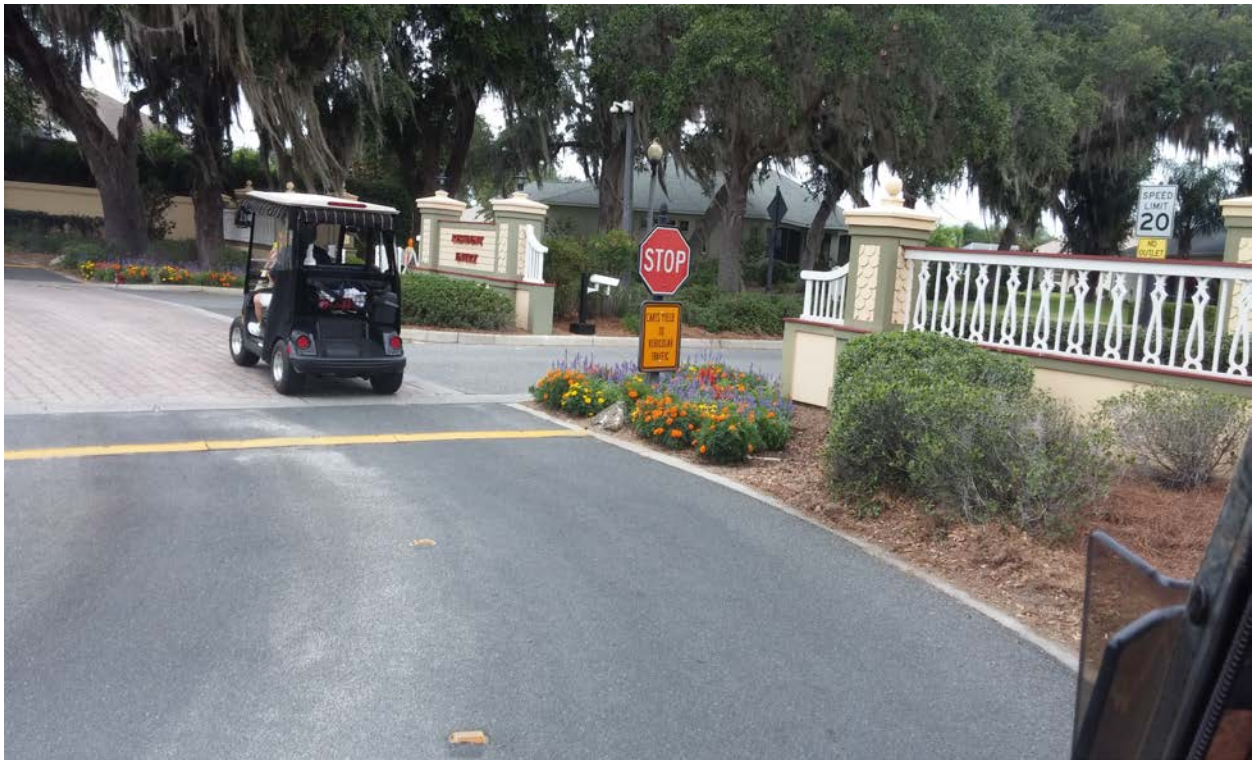
**Photo A.** Taken from a golf cart positioned on the mm path right after the curve approaching the stop area for carts heading toward Arnold Palmer Restaurant.

An exiting vehicle, if not near the gate, can be difficult to see through the lattice work.

**Now is the time to finally address this line-of-sight issue at BLS. Removal or lowering of the entry sign, removal of the shrubbery, and lowering of the electrical boxes into a “well” should open up the area for all traffic, and relieve the considerable anxiety experienced by those entering, leaving, and crossing through the area.**

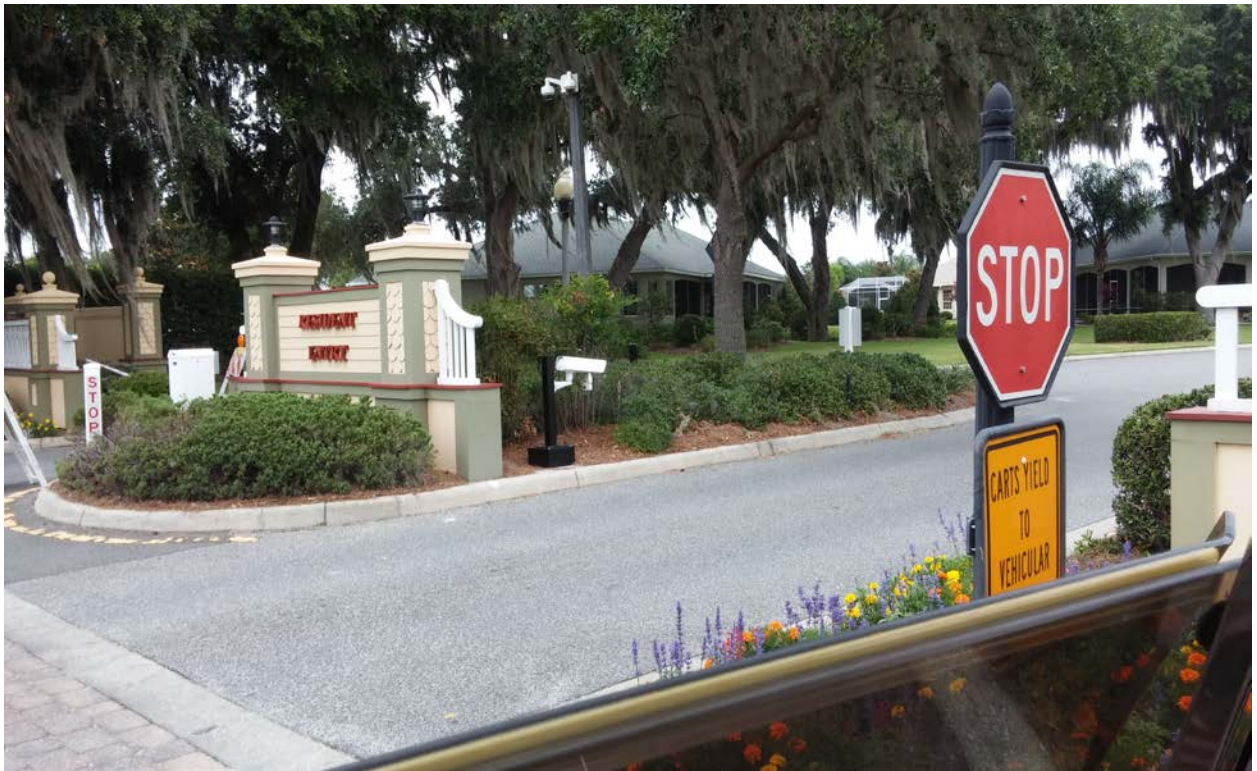
**Photo B.** As Photo A, but the golf cart is now located at the stop position.

An exiting vehicle (especially a golf cart) that is near the gate cannot be seen as it is hidden by the Resident Entry sign and the shrubs.

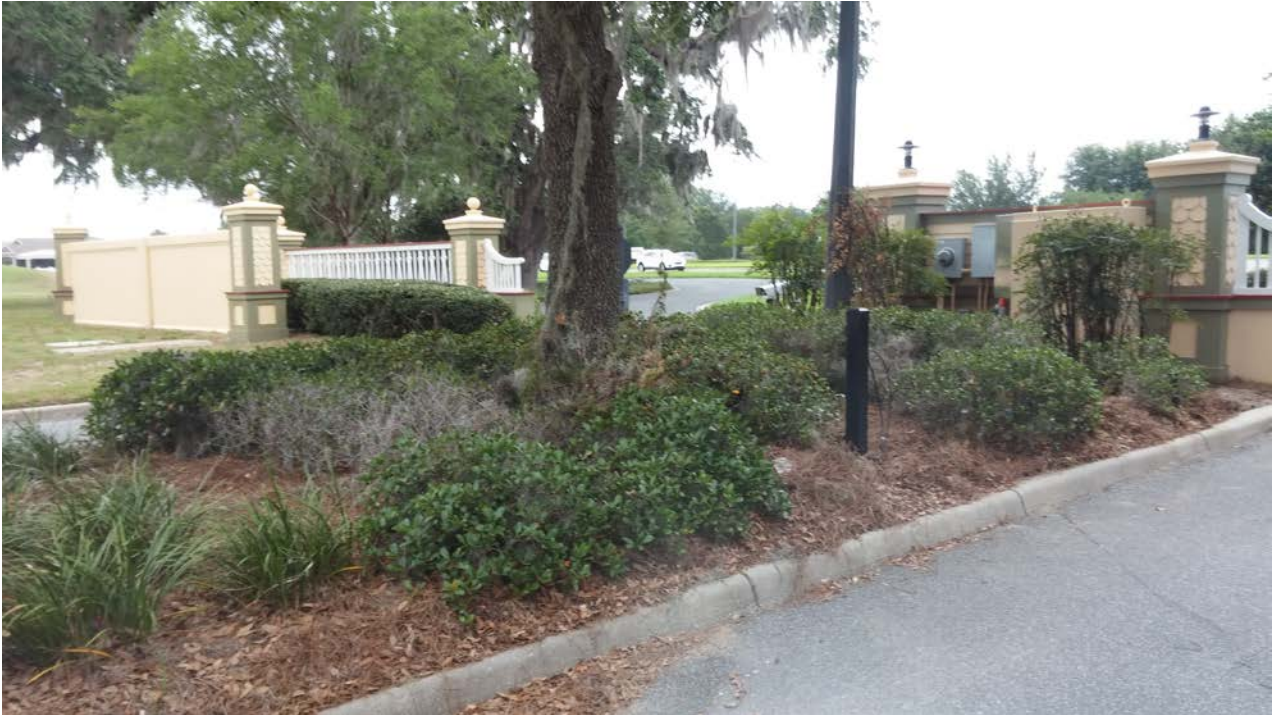
**Photo C.** Taken from a golf cart positioned about 20 feet from the **exit** gate leaving the Village.

An exiting vehicle “might” see a cart waiting to cross in front of the entry gate, but cannot see a cart that is part way across the mm path.

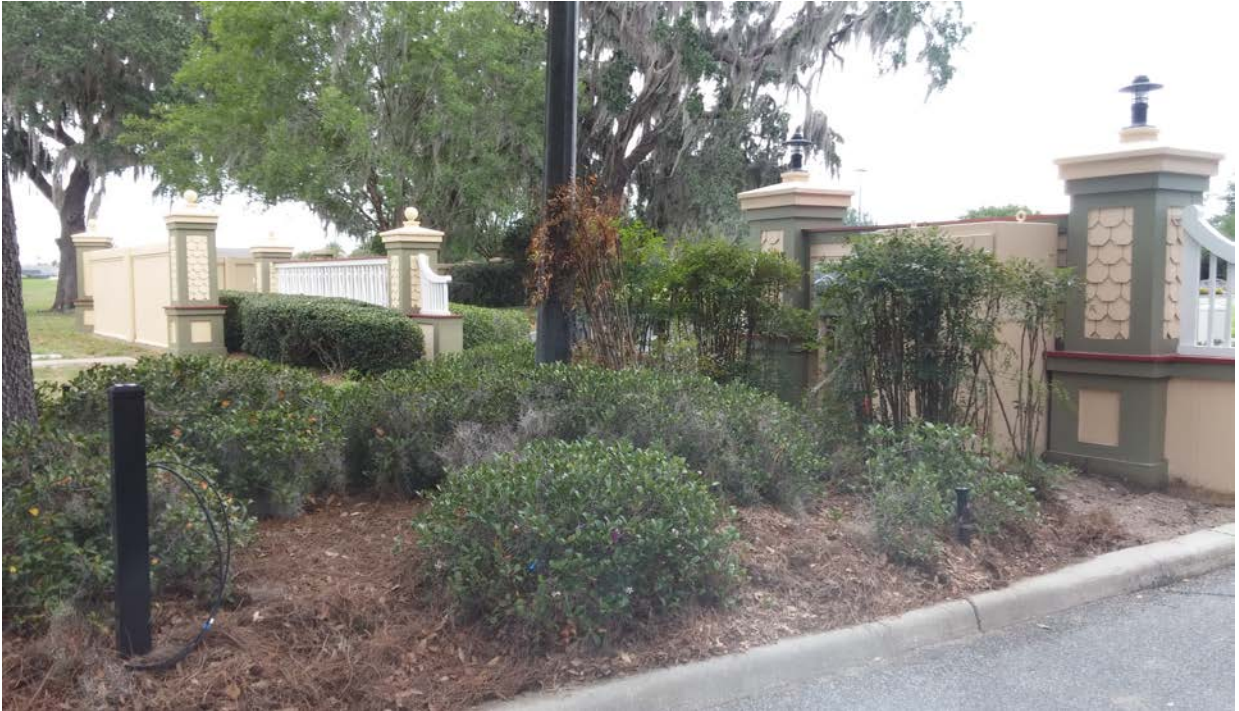
**Photo D.** Taken at the **exit** gate when leaving the Village.

An exiting vehicle near the gate cannot see a cart waiting to cross in front of the entry gate, nor can the vehicle be seen by a cart beginning to enter the multi modal path on their left. A cart part way across will not be seen.
