Memorandum

RE: ***Village of Bridgeport MUT Crossing Recommendations***
Kimley-Horn Project No: 142281002

Per your request, Kimley-Horn performed a field review and evaluation of the multi-use trail (MUT) crossing at the Buena Vista Boulevard entrance to The Village of Bridgeport. This memorandum summarizes our field observations and recommendations.

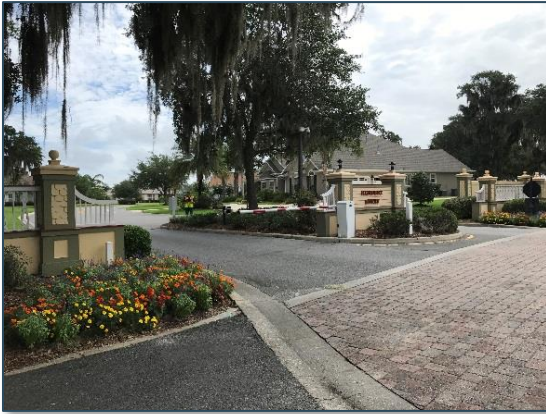
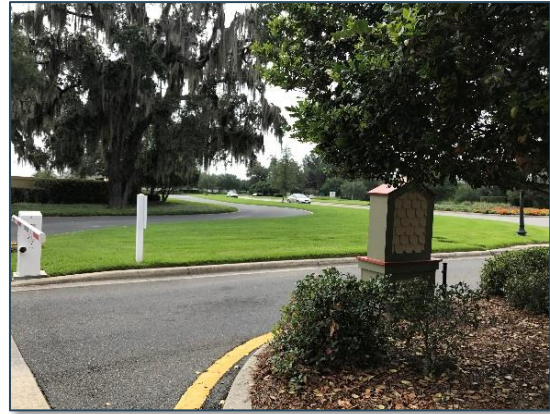
1. **Eastbound Golf Carts** – The sight line for southbound exiting vehicular traffic at the gate is slightly limited by the fence adjacent to the crossing, but not obstructed. The sight line for northbound entering traffic is slightly limited by the landscaping and gate activation push button, but not obstructed.

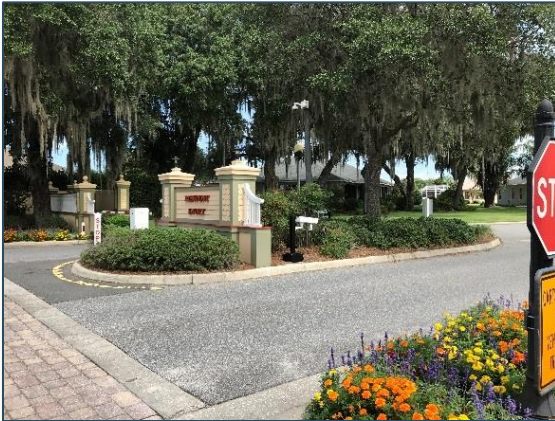
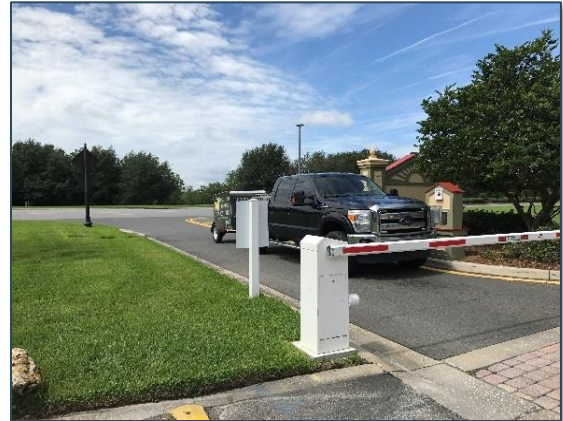
2. **Westbound Golf Carts** – The sight line for southbound exiting traffic at the gate is obstructed by the “Resident Entry” sign and landscaping located within the median adjacent to the gate. When a vehicle is stopped behind the exiting gate it is difficult for the southbound golf cart to see them. The sight line for northbound entering traffic is clear.

1. Modify the “Resident Entry” sign to allow visibility for westbound golf carts and southbound exiting vehicles to see each other. Remove / replant any landscaping in this sight line.
2. Modify the entering gate activation push button housing to allow visibility for southbound entering vehicles to see eastbound travelling golf carts.
3. Adjust the timing on the southbound existing gate arm to require a single exiting vehicle to make a full stop before the gate opens. Currently, a car approaching this gate can continue through the gate arm without stopping if they slow down.
4. Modify the median refuge area to improve the two-stage golf cart crossing. Replace and clearly post the stop signs in the median. On the date of our field visit one was missing and the one that was present was obstructed by landscaping.
5. Address the speed bumps on the MUT, as described below.

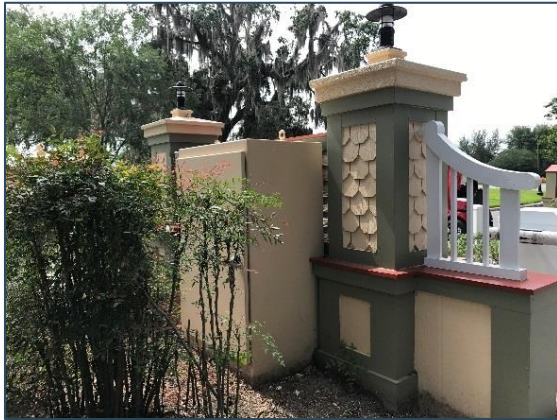
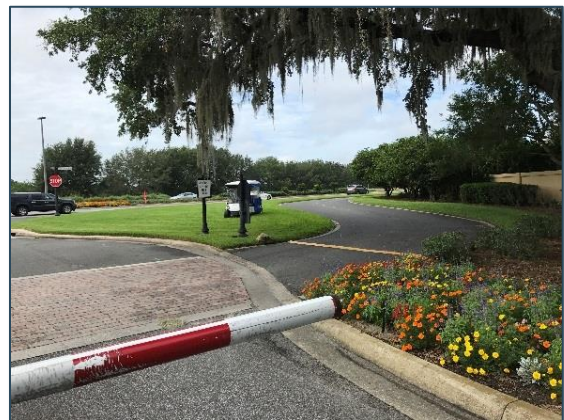
- 3. Southbound Exiting Vehicles** – The sight line for westbound golf carts is obstructed by the “Resident Entry” sign and landscaping located within the median adjacent to the gate. When an exiting vehicle is stopped waiting for the gate to open they cannot see westbound golf carts. The sight line for eastbound golf carts is clear.

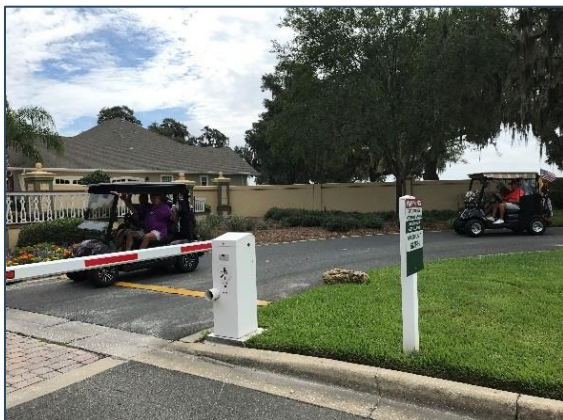
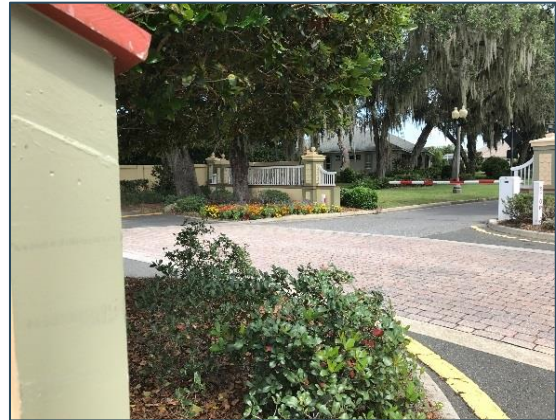
- 4. Northbound Entering Vehicles** – The sight line for westbound golf carts is clear. The sight line for eastbound golf carts is obstructed by the housing for the gate activation push button. The gate housing is directly in the line of sight of vehicles pushing the gate activation button and entering vehicles have an obstructed view of eastbound golf carts.

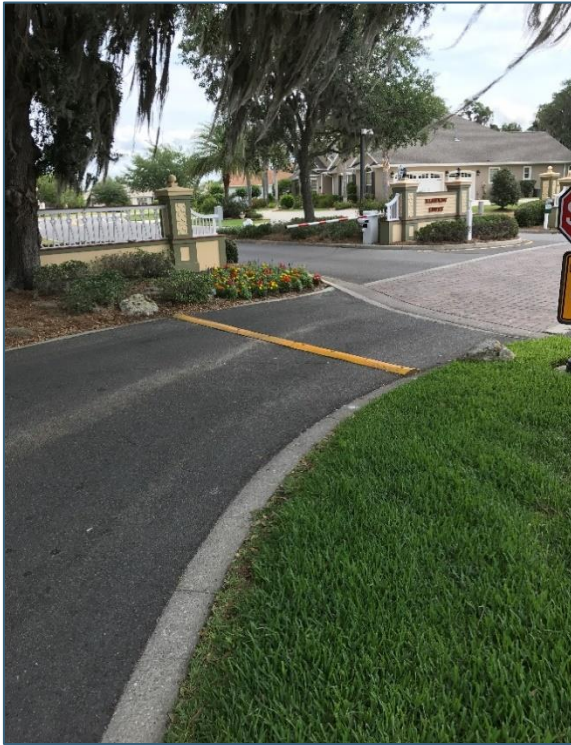
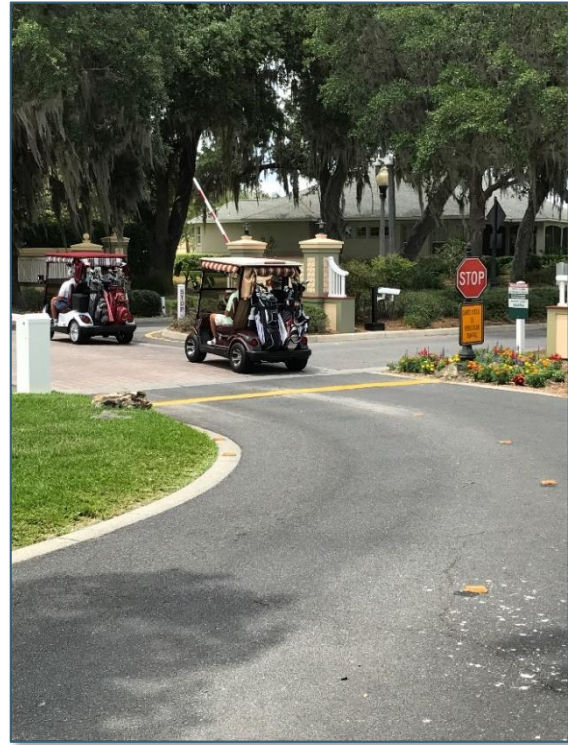
Speed Bumps on MUT crossing at The Village of Bridgeport

Speed bumps were installed by the VCDD6 in 2007 in an attempt to get carts to stop at the stop signs on the path. Indeed, much of the operation of the intersection would be greatly improved if cart drivers obeyed the posted regulatory signage. Though speed bumps are not recommended by Kimley-Horn at this location and there is widespread consensus in the transportation industry that speed bumps are inappropriate for bicyclists and pedestrians, the decision of whether or not to keep them can be at the discretion of the VCDD6. Kimley-Horn observed that the presence of speed bumps at this location may actually be inducing cart drivers to slow to a roll to navigate the speed bumps instead of coming to a full stop at the stop signs. We observe the following regarding speed bumps at this location:

1. The speed bumps appear to encourage “rolling stops” at these locations.
2. The speed bumps are the full width of the trail, which means that a cart that has just crossed the entrance must then also slow down for another speed bump on the other side. We observed regular backups because of this issue.
3. In the westbound direction, the location of the speed bump is such that the golf carts must actually straddle the bump to obey the posted stop sign.
4. Speed bumps are not appropriate for bicyclists or pedestrians.

If the District keeps the speed bumps, they should be relocated further from the intersection to allow for a golf cart to stop at the stop sign without having to straddle the speed bump. The speed bump should also be limited to the approaching lane only and removed from the receiving lane so as not to

cause slowing of the golf carts within the vehicular travel lane. If the speed bumps are removed, we recommend that a painted stop bar and "STOP" message be added to the asphalt at this location for enhanced warning for carts to stop.
