**Geology in Central Florida
and
Update Regarding District Owned Road
and Storm Pipe
McLawren Terrace**

March 9, 2018

District 4 Board of Supervisors

The Villages®
Community Development Districts

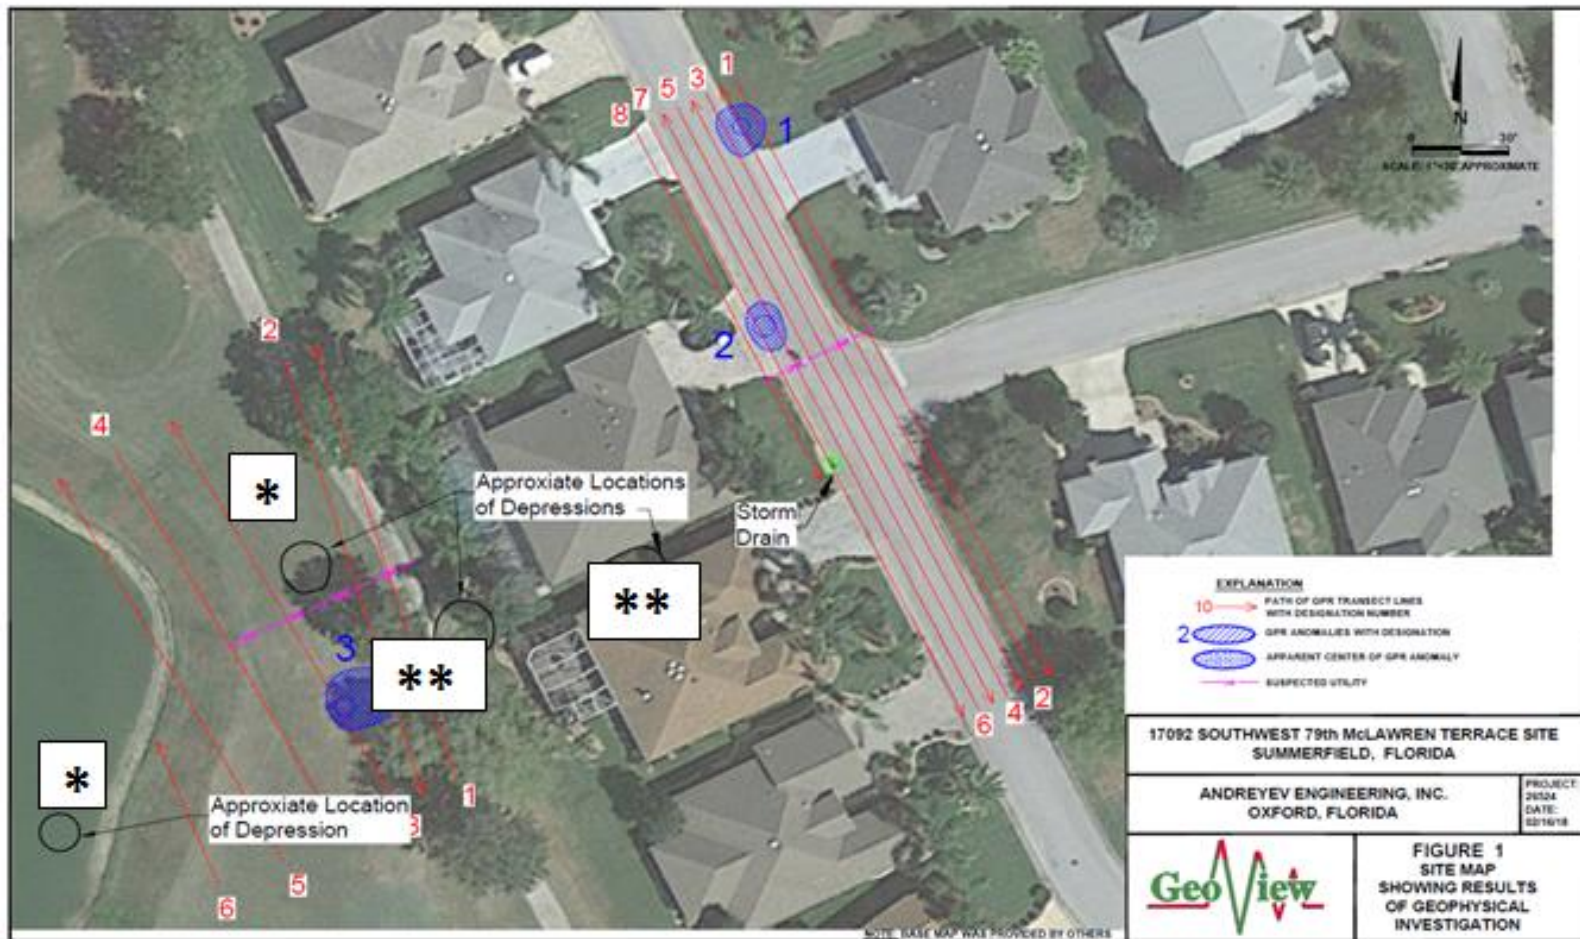
SE 79th McLawren Terrace

* Outside of District Maintained
Infrastructure Locations

** Depression Locations along
Stormwater Outfall Pipe
