# MORSE BOULEVARD LAKE SUMTER SLOPE STABILITY ANALYSIS

## Sumter Landing Community Development District

**Kimley-Horn and Associates, Inc.**

142202018  
July 2016  
© Kimley-Horn and Associates, Inc.  
Suite 200  
1823 SE Fort King Street  
Ocala, Florida 34471  
352 438 3000

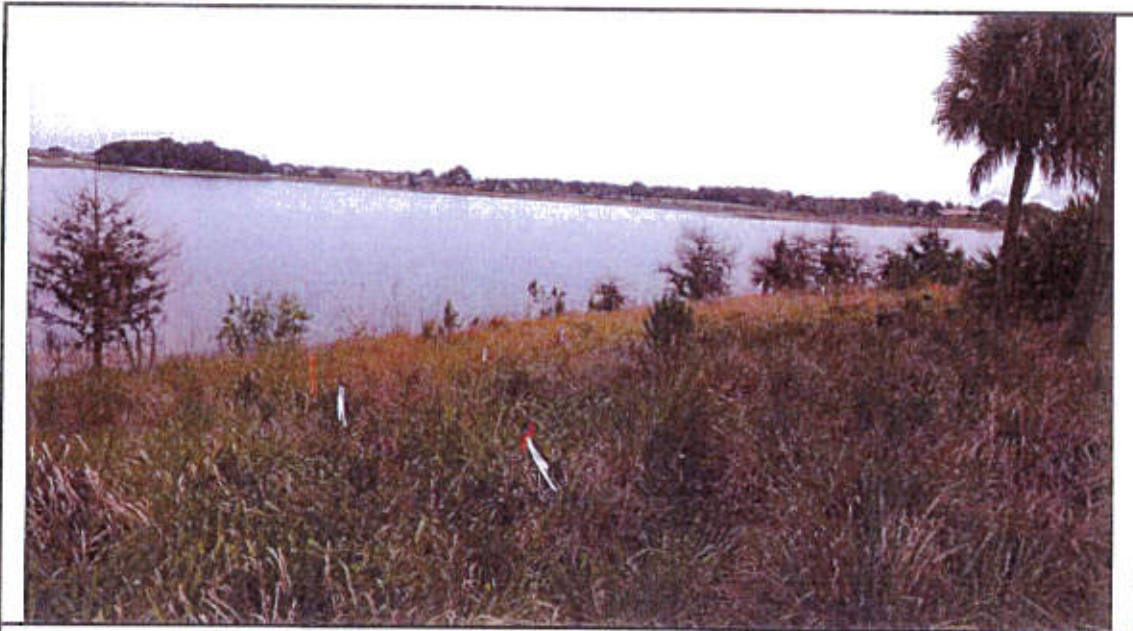
**Photo 1:** Morse Island vegetation cover.

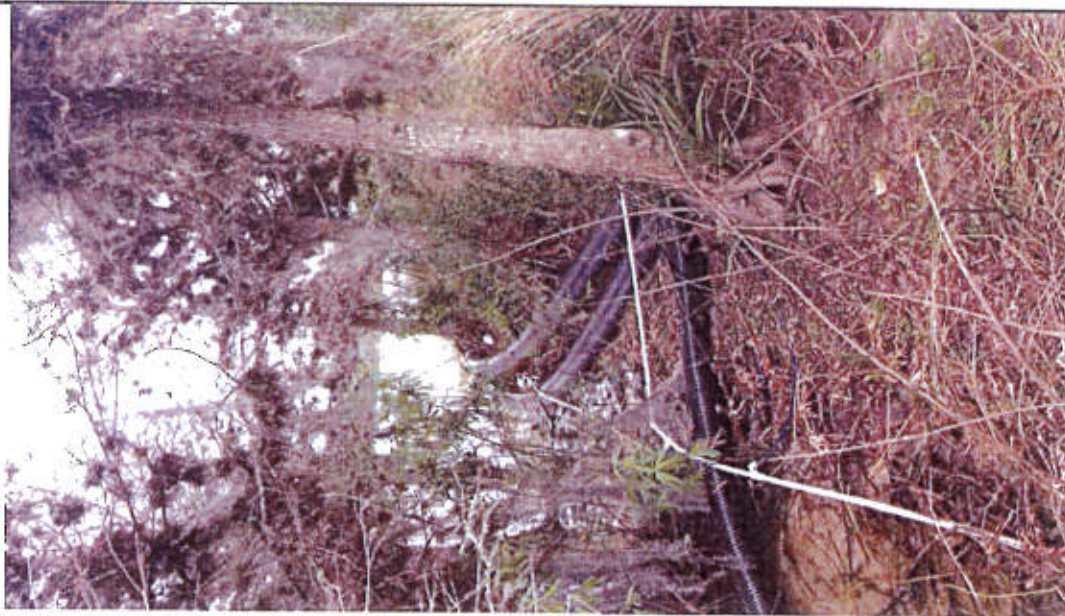
**Photo 2:** Exposed utility and irrigation pipes, northwest corner.

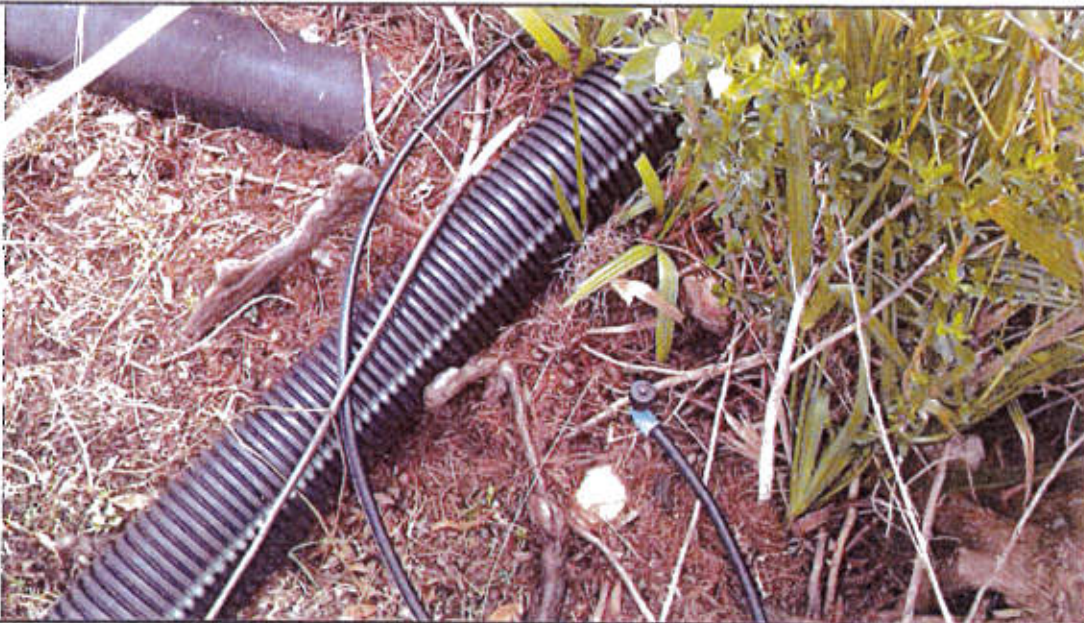
**Photo 3:** Exposed utility and irrigation pipes, northwest corner.

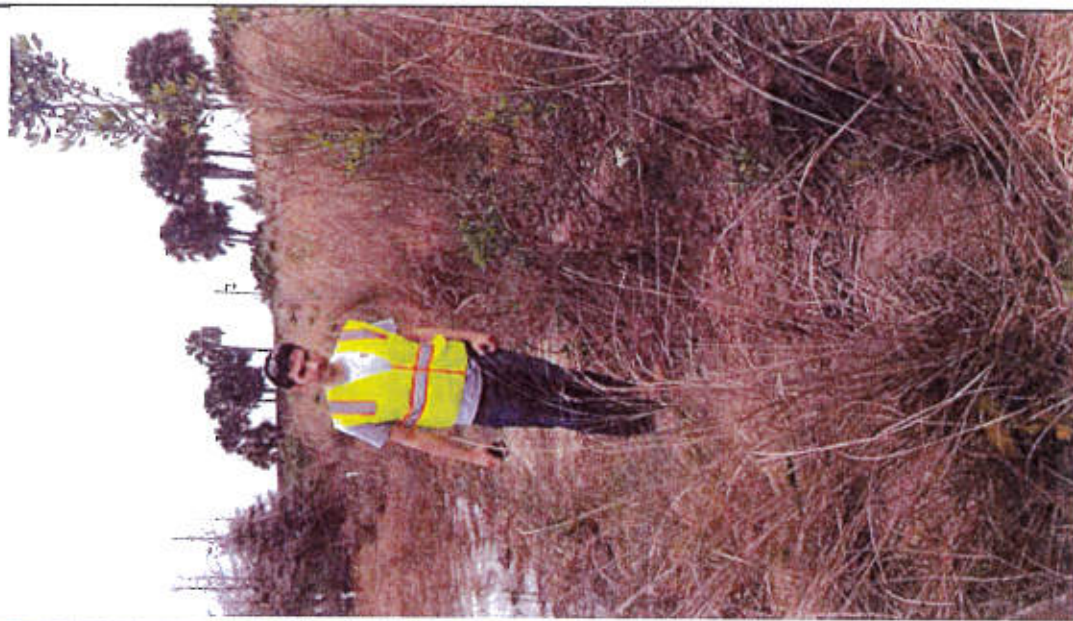
During PSI's site visit, visible erosion of the slope toe at the water's edge was observed. This condition was observed around a majority of the island's perimeter. If gravel or stone rip-rap is used, a filter fabric material should be placed between the existing slope and gravel/stone to prevent soil from migrating into the gravel/stone layer. A woven geotextile fabric meeting the requirements of FDOT is recommended.

**Photo 4:** Slope toe erosion.

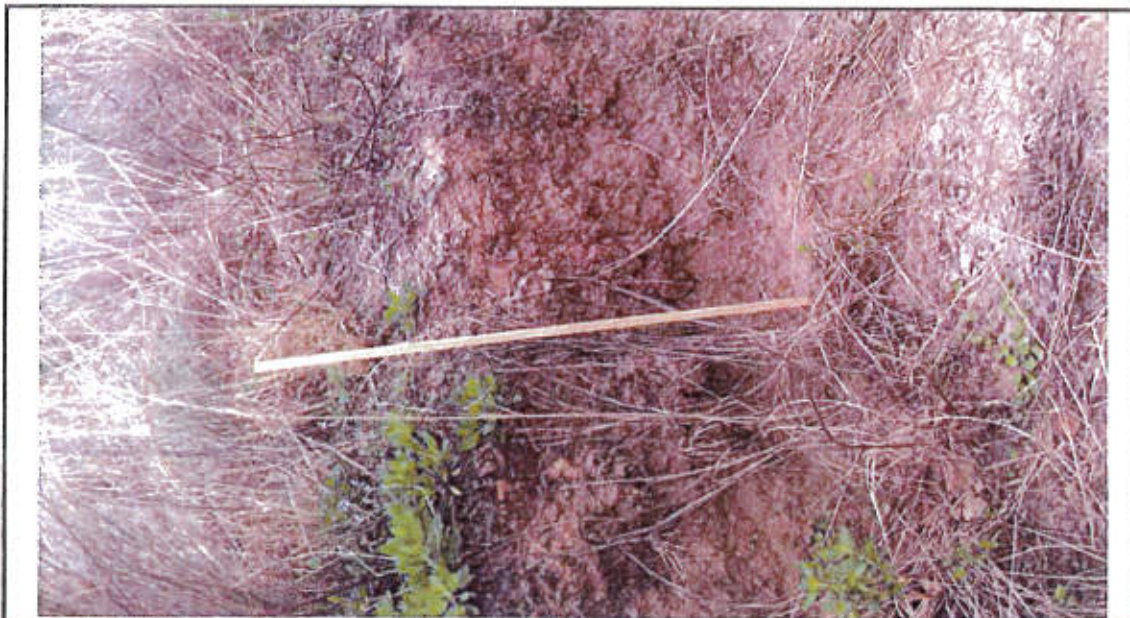
**Photo 5:** Slope toe erosion.

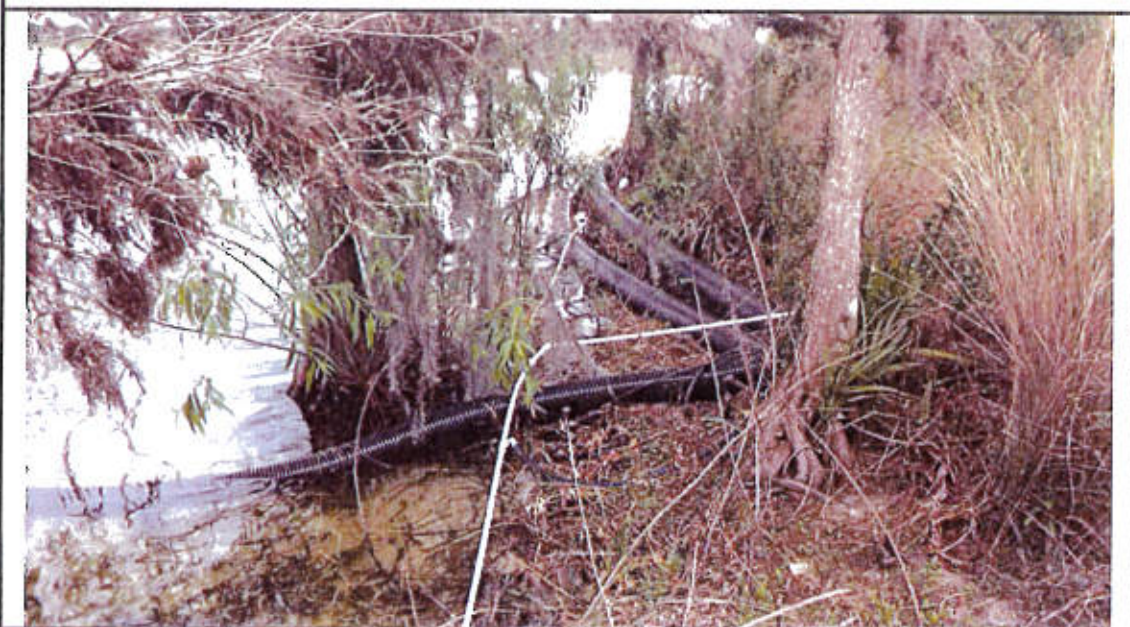
**Photo 6:** Exposed utilities due to slope erosion.

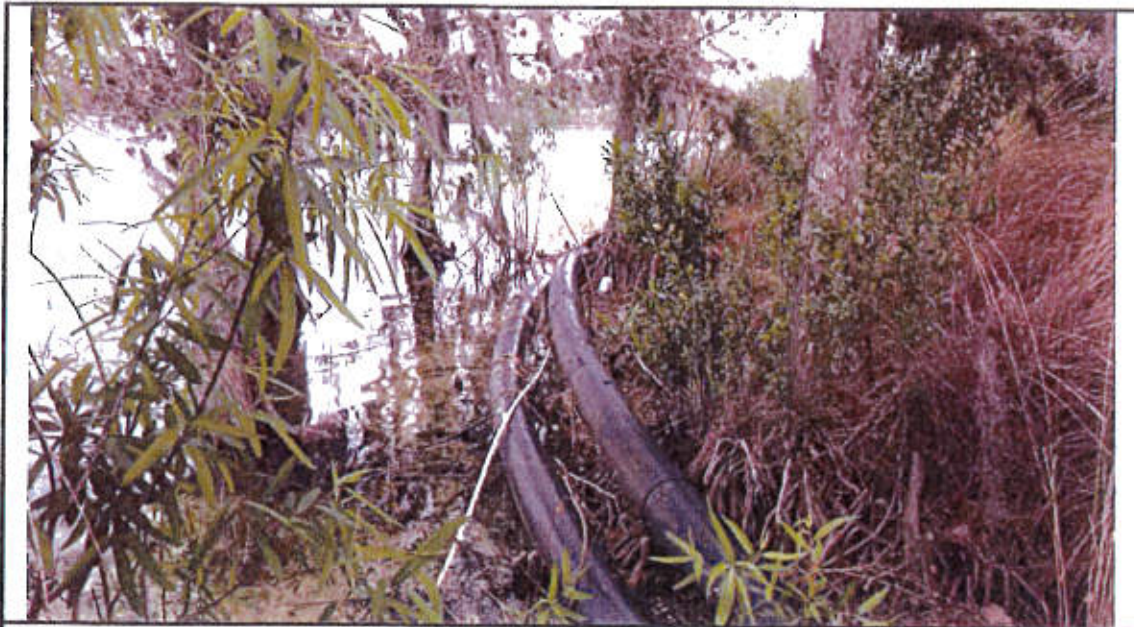
**Photo 7:** Exposed utilities due to slope erosion.

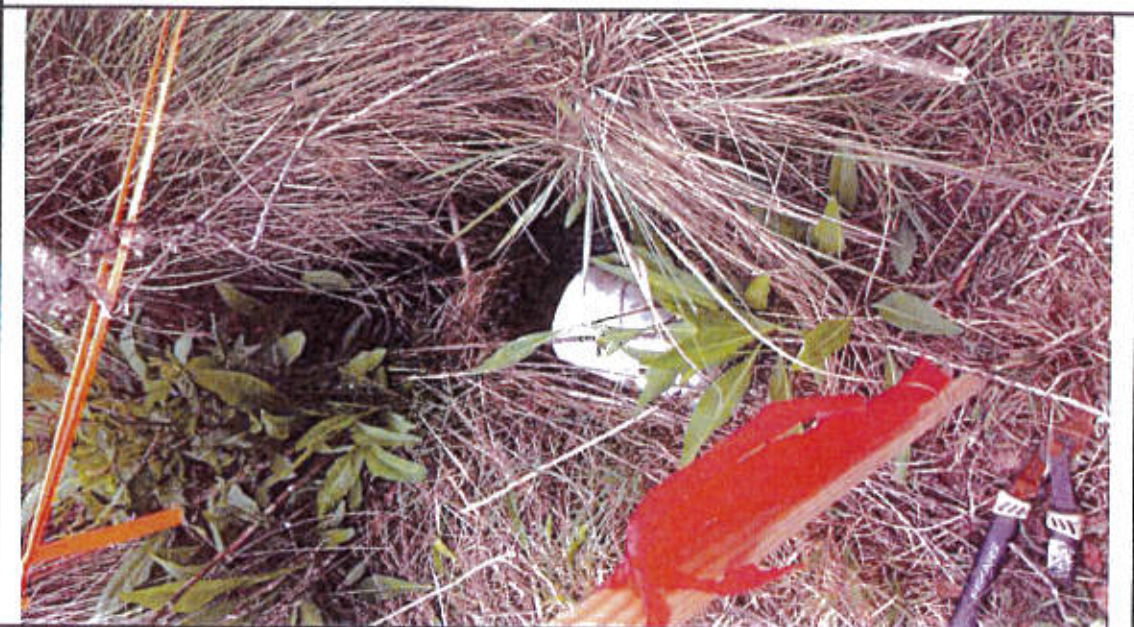
**Photo 8:** Drainage outfall – west side.

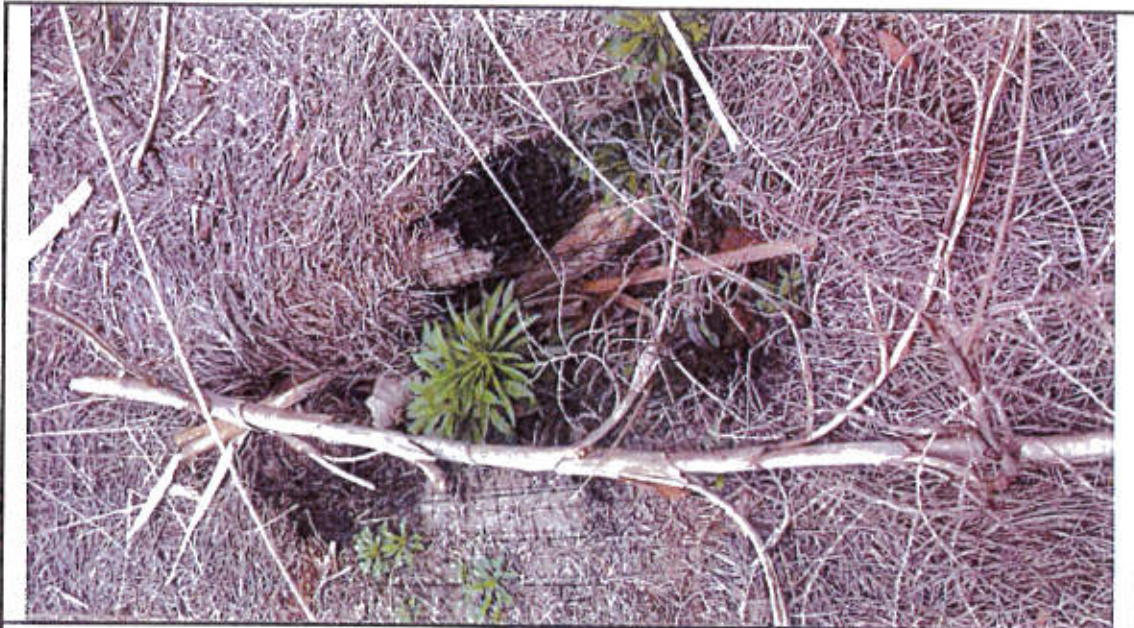
As stated earlier, new signs of surface erosion at the recently reconstructed northeast slope were observed by PSI during our site visit. The erosion appears to be caused by surface water flowing down the slope face, washing the slope soils into Cherry Lake. **Photographs** showing the erosion are included in the **Appendix**. To reduce the surface erosion, maintaining the existing slope by vegetating the slope surface and regular inspection and maintenance should be considered.

Photo 9: Slope erosion – northeast corner.

Employing surface reinforcement systems from the FDOT approved geosynthetic products in the area of the exposed slope along with vegetation maintenance will reduce the chances of future slope failures and erosion. Using geosynthetic reinforcement should also reduce future maintenance cost compared to Option 1. It should be noted that if this option is selected, the installation of the geosynthetic material requires clearing all the existing vegetation, re-grading the slope and re-planting over the geosynthetic erosion protection material.

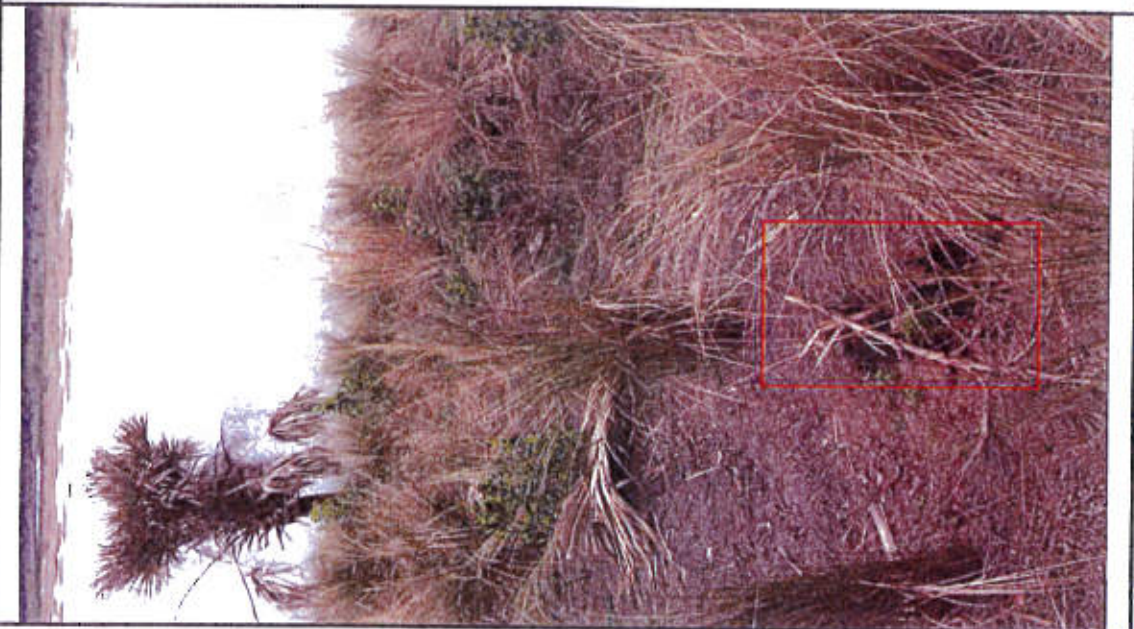
Photo 10: Slope erosion – northeast corner.

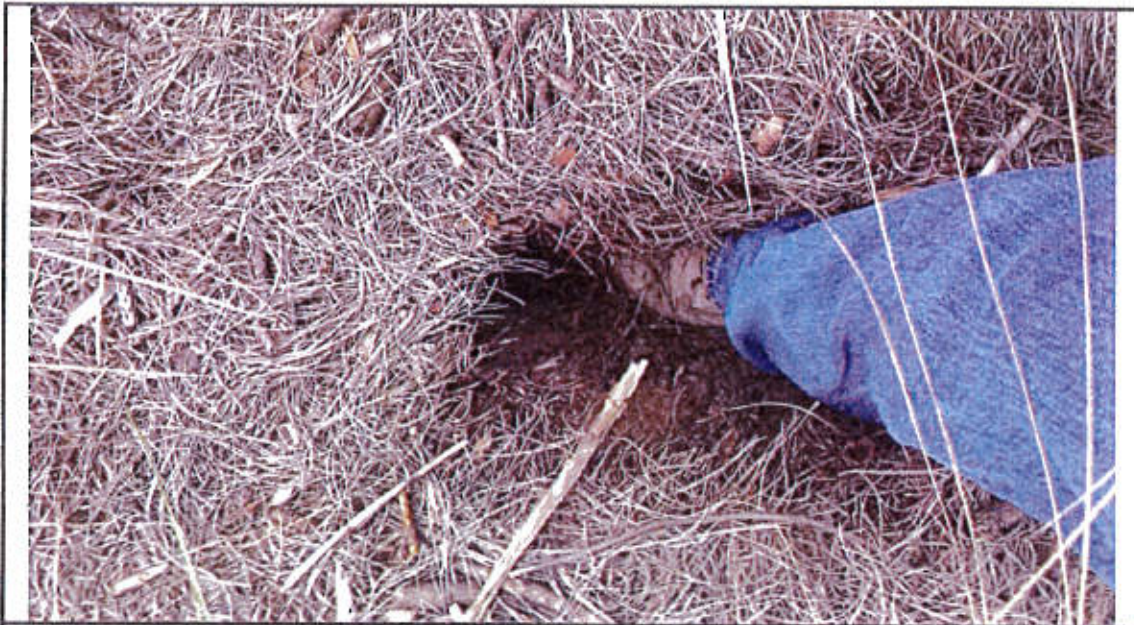
Photo 11: Slope erosion – northeast corner.

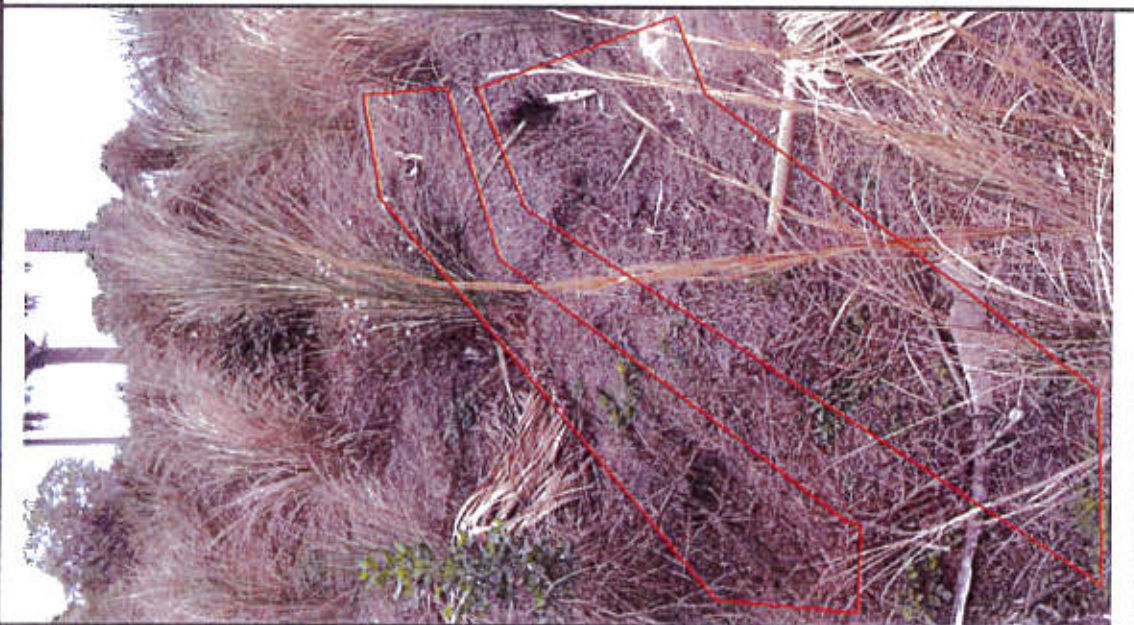
Photo 12: Slope erosion – northeast corner.

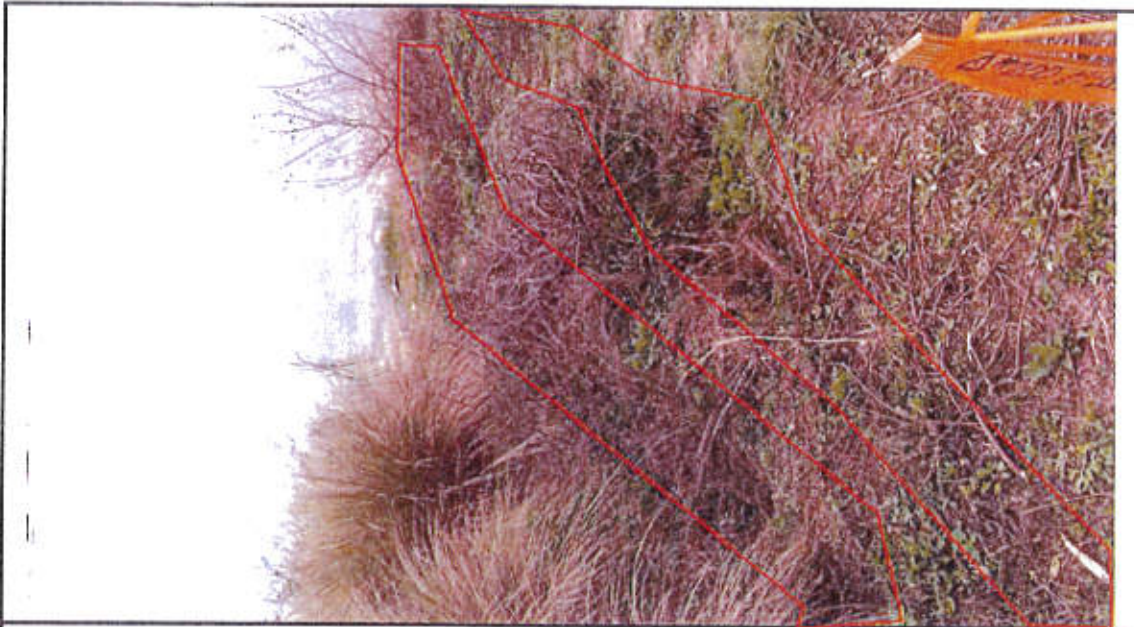
**Photo 13:** Slope erosion – northeast corner

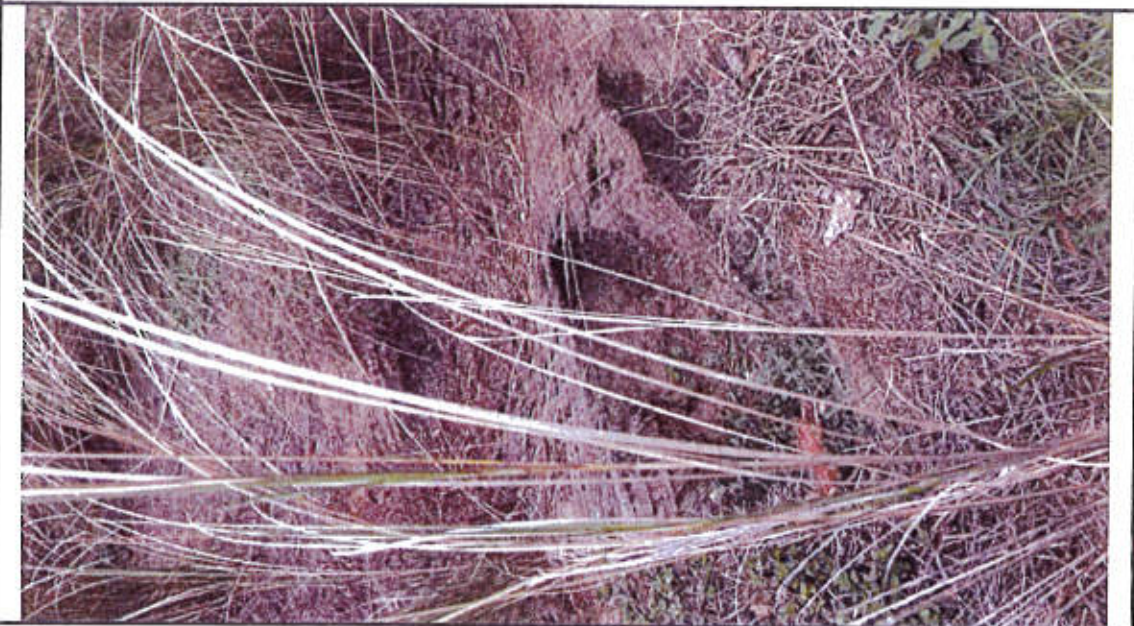
**Photo 14:** Slope erosion – northeast corner.

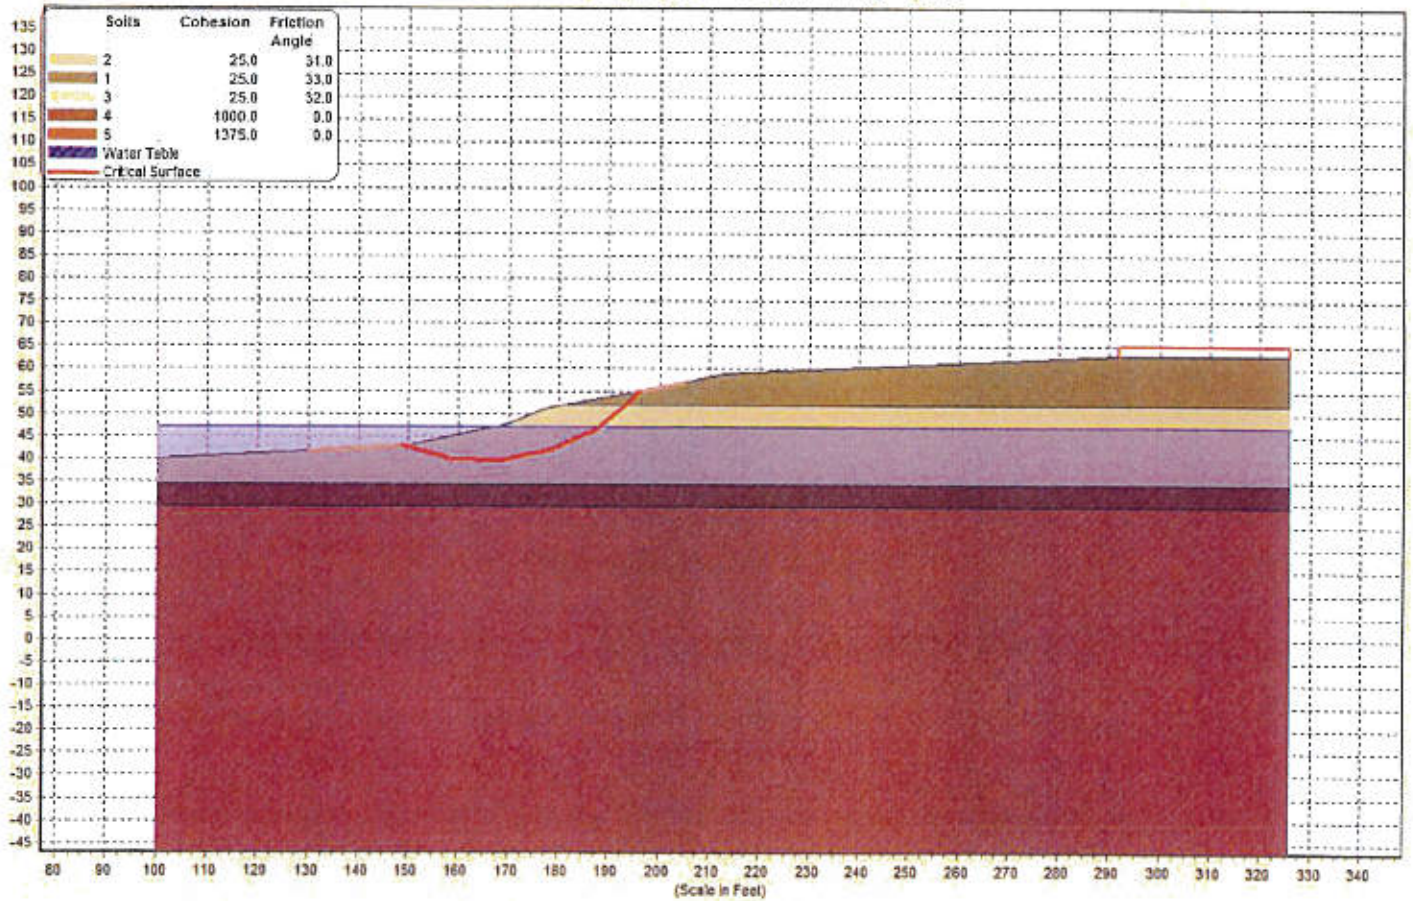
Problem: Morse Island \_ B-2 - FS Min- Bishop = 2.163

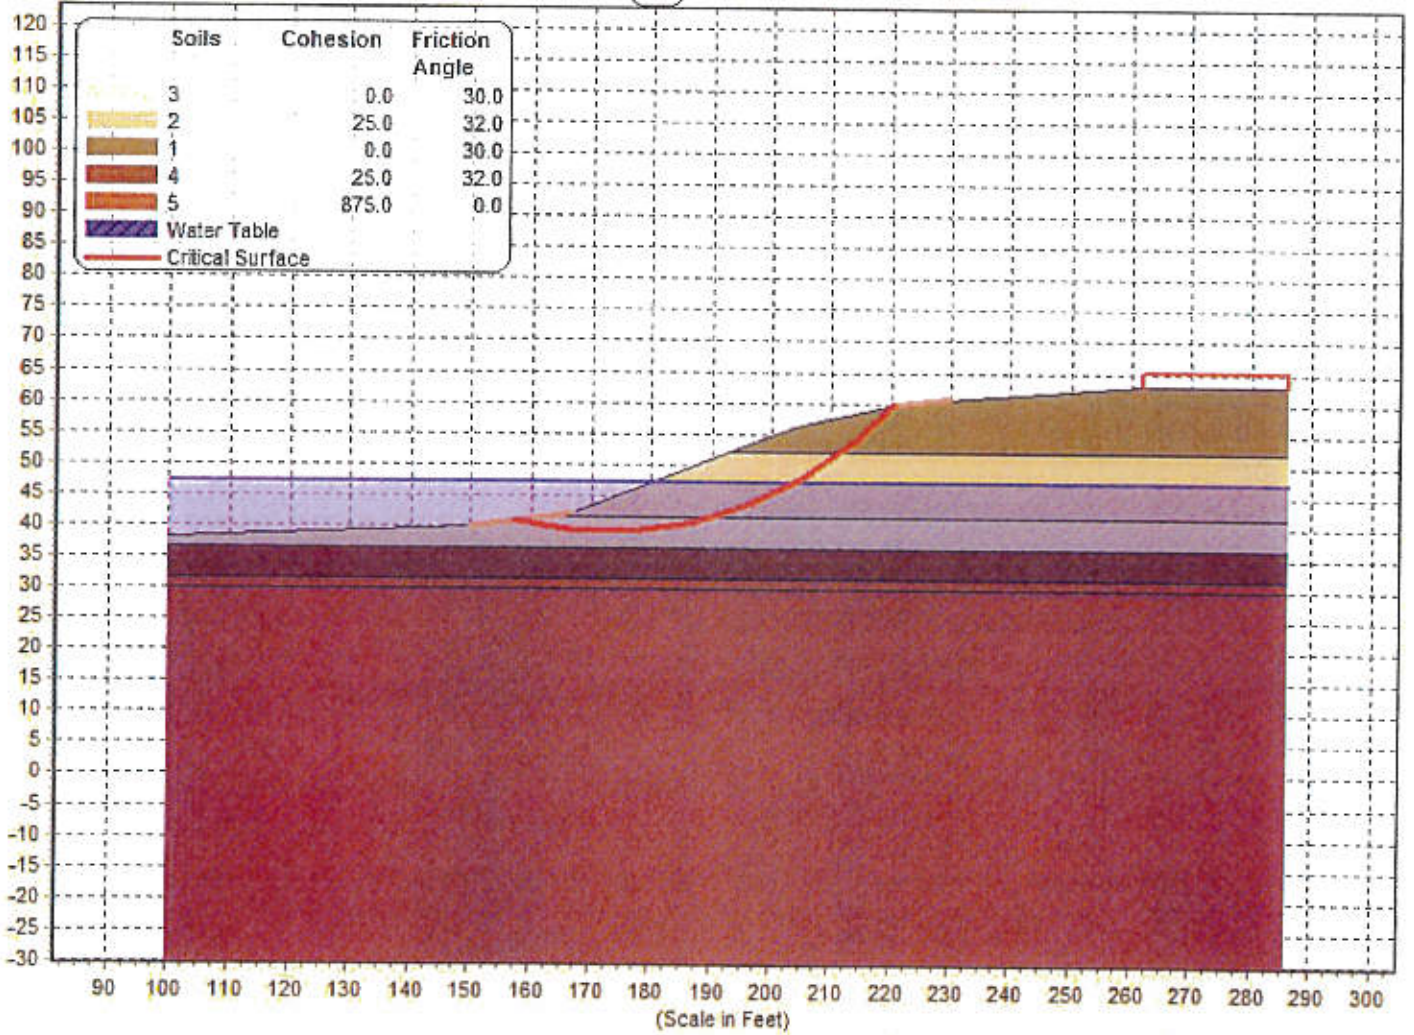
Problem: Morse Isl (B-6) - FS Min- Bishop = 1.681
