# MORSE BOULEVARD LAKE SUMTER SLOPE STABILITY ANALYSIS

## Sumter Landing Community Development District

**Kimley-Horn and Associates, Inc.**

142202018  
July 2016  
© Kimley-Horn and Associates, Inc.  
Suite 200  
1823 SE Fort King Street  
Ocala, Florida 34471  
352 438 3000

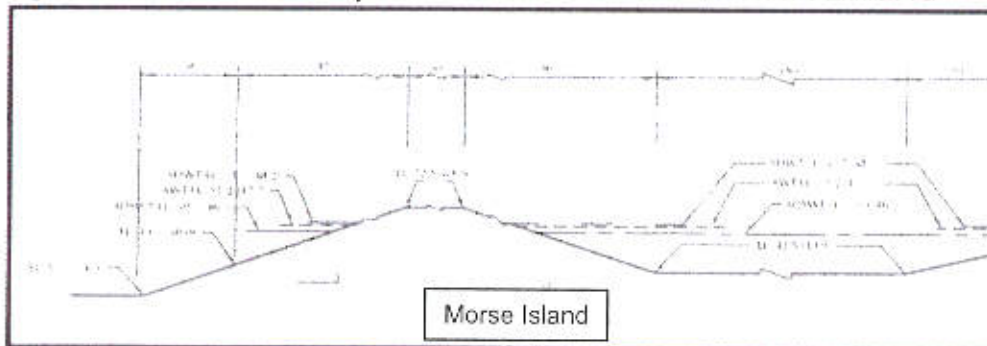
Figure 2: Profile 9 From Cherry Lake Post-Reclamation Cross-Sections Exhibit 7a

As shown in Figure 2 above, the side slopes of Morse Island were designed and constructed to be equivalent to approximately 1 vertical to 3 horizontal both above and below the water line. The survey data and field visit photographs indicate that sediment has eroded from above the water line and settled

to below the water line, developing a shallower side slope below the water line. This movement of the sediment is known as profile equilibration. Sediment will continue to move from the higher portion of the profile to the lower portion of the profile until the profile reaches an equilibrated state. There is a great deal of research focused on open coasts with depth limited wave conditions. Much less research is available for fetch limited coastlines. For open coasts with depth limited waves, the equilibrated profile can be predicted based upon the median grain size of the sediment present at a given site. For fetch limited project sites, the equilibrated profile will likely over predict the amount of sediment which will move offshore. This will predict a flatter profile than is expected and is not appropriate for this site. An equilibrated profile with a slope closer 1 vertical to 10 horizontal than the existing 1 vertical to 3 horizontal is what is expected for this site.

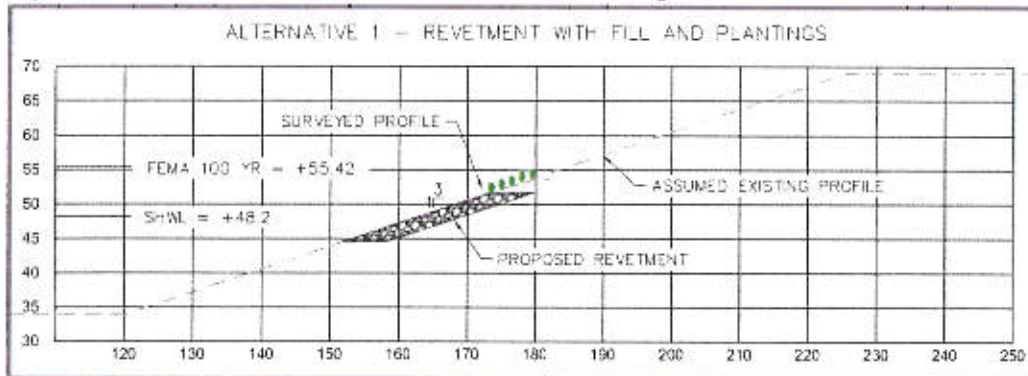
Figure 7a: Alternative 1 – Revetment with Fill and Plantings

improve the appearance of the revetment, the revetment can be designed around the existing trees. The revetment will provide the most protection of the upland due to the added protection during higher water elevation events and protection against wave runup. Figure 7a below depicts a conceptual level cross-section view of the revetment. Figure 7b below is a photograph of a typical revetment structure taken on the eastern shoreline of the Indian River Lagoon in Vero Beach, Florida.

The first alternative consists of a rock revetment structure with additional fill and native plantings. The rock revetment structure consists of installing coarse sands to repair the existing erosion, placing filter fabric to keep the soil from eroding and rock on top of the layer of filter fabric to hold the filter fabric in place. The required median rock was sized using the Hudson formula shown below. The Hudson formula confirmed that the rock specified in the FDOT Standard Specification 530-2.1.3.1 Rubble (Bank and Shore Protection) is adequately sized for the shoreline stabilization of Morse Island. The Hudson Formula assumes 5% damage during the design wave condition. Therefore, the revetment structure could require maintenance after significant storm events. The maintenance will consist of rocks being moved back into place or replaced with the placement of new rocks. The seaward terminal point and landward terminal point of the revetment was determined consistent with the USACE Shore Protection Manual. The landward extent of the revetment was determined as the landward extent of expected wave run-up. The seaward extent of the revetment was determined as the expected scour depth assuming a low risk of scour.

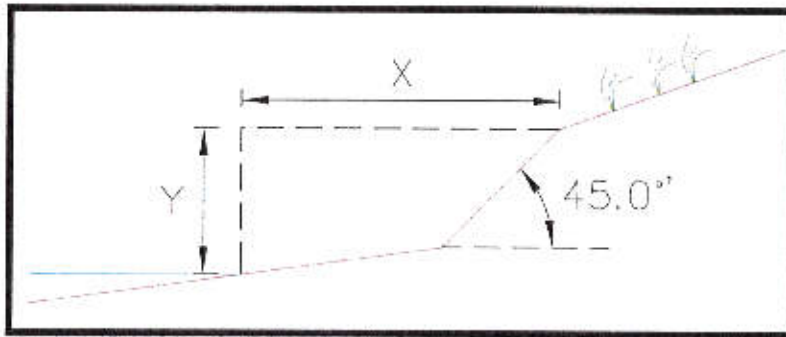
Escarpment Typical Section

WEST SIDE OF ISLAND			
Station	Escarpment		Observation
	X (ft)	Y (ft)	
6+22	5	3.5	Soil surface 4" below an existing tree (shrub) - indicative of wave slap erosion at water edge. Escarpment continues to approx. STA. 5+95 (cabbage palm).
6+07	5.5	4.5	Bank escarpment stable due to clayey soils (cohesive). Stiff soils.
6+00	2.5	4	
5+85			Clayey soils continue. Rigid escarpment.
5+50			Surface erosion (gully or foot path). 6" HDPE drain pipe. Rod probe indicated soft soils (possible backfill to HDPE pipe).
5+00	8	4	Escarpment stable, high clay content. Rod probe indicates stiff soils.
4+75			(2) 8" HDPE pipes to approx. STA. 4+50 laid parallel to shore (for erosion?). Irrigation to cypress trees in water.
4+50			6" HDPE pipe into water. Clayey soil present but backfill soft (probe). Cypress tree in soil.
4+30			Sandy soils but stiff.
4+10			Concrete slab with 4" PVC stand pipe with 90° fitting and 2" reducer at top. Possible old well pump location.

EAST SIDE OF ISLAND			
Station	Escarpment		Observation
	X (ft)	Y (ft)	
7+00			Landscape/erosion control netting present. Vegetation to waterline (in water also). Rod probe shows soft soils. No escarpment.
6+80			Sandy soils. Escarpment present. Water is 3.5' deep 5.0' off water edge.
6+70			Recent movement noted. Slopes sandy. Landscape/erosion control netting present. Plants of same species at different contours. Tree in water (approx. 3.0' deep).
6+40	4	2	Escarpment present from 15' to north to 40' to south
6+00			Cypress tree at waterline. 6" of water up tree trunk on waterside. No escarpment. Landscape/erosion control netting present.
5+40			(2) 20' palm trees sloughed down slope. Appears trees may have also leaned into bank and soil eroded around trees. Landscape/erosion netting at each tree base.
			North tree covered in soil up to beginning of old leaf sheaths. South tree at water edge.
5+00			Rod probe indicates sandy soils present.

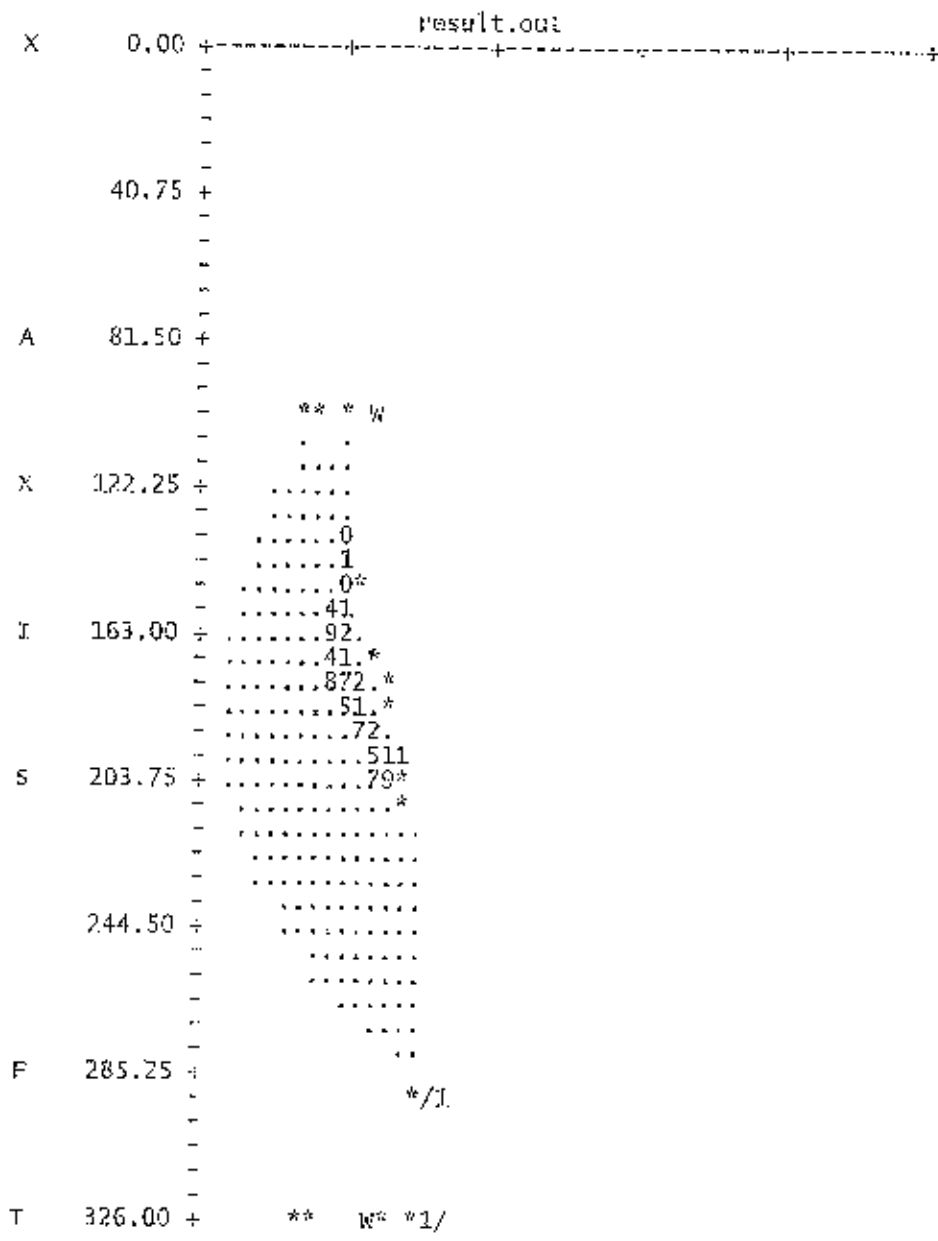
Problem: Morse Isl (B-6) - FS Min- Bishop = 1.681
